Debris/Ice/TPS Assessment and Integrated Photographic Analysis of Shuttle Mission STS-87

*Process Engineering/Mechanical System Division/ET-SRB Branch,
Kennedy Space Center, Florida*

**DEBRIS/ICE/TPS ASSESSMENT
AND
INTEGRATED PHOTOGRAPHIC ANALYSIS
OF
SHUTTLE MISSION STS-87**

19 November 1997

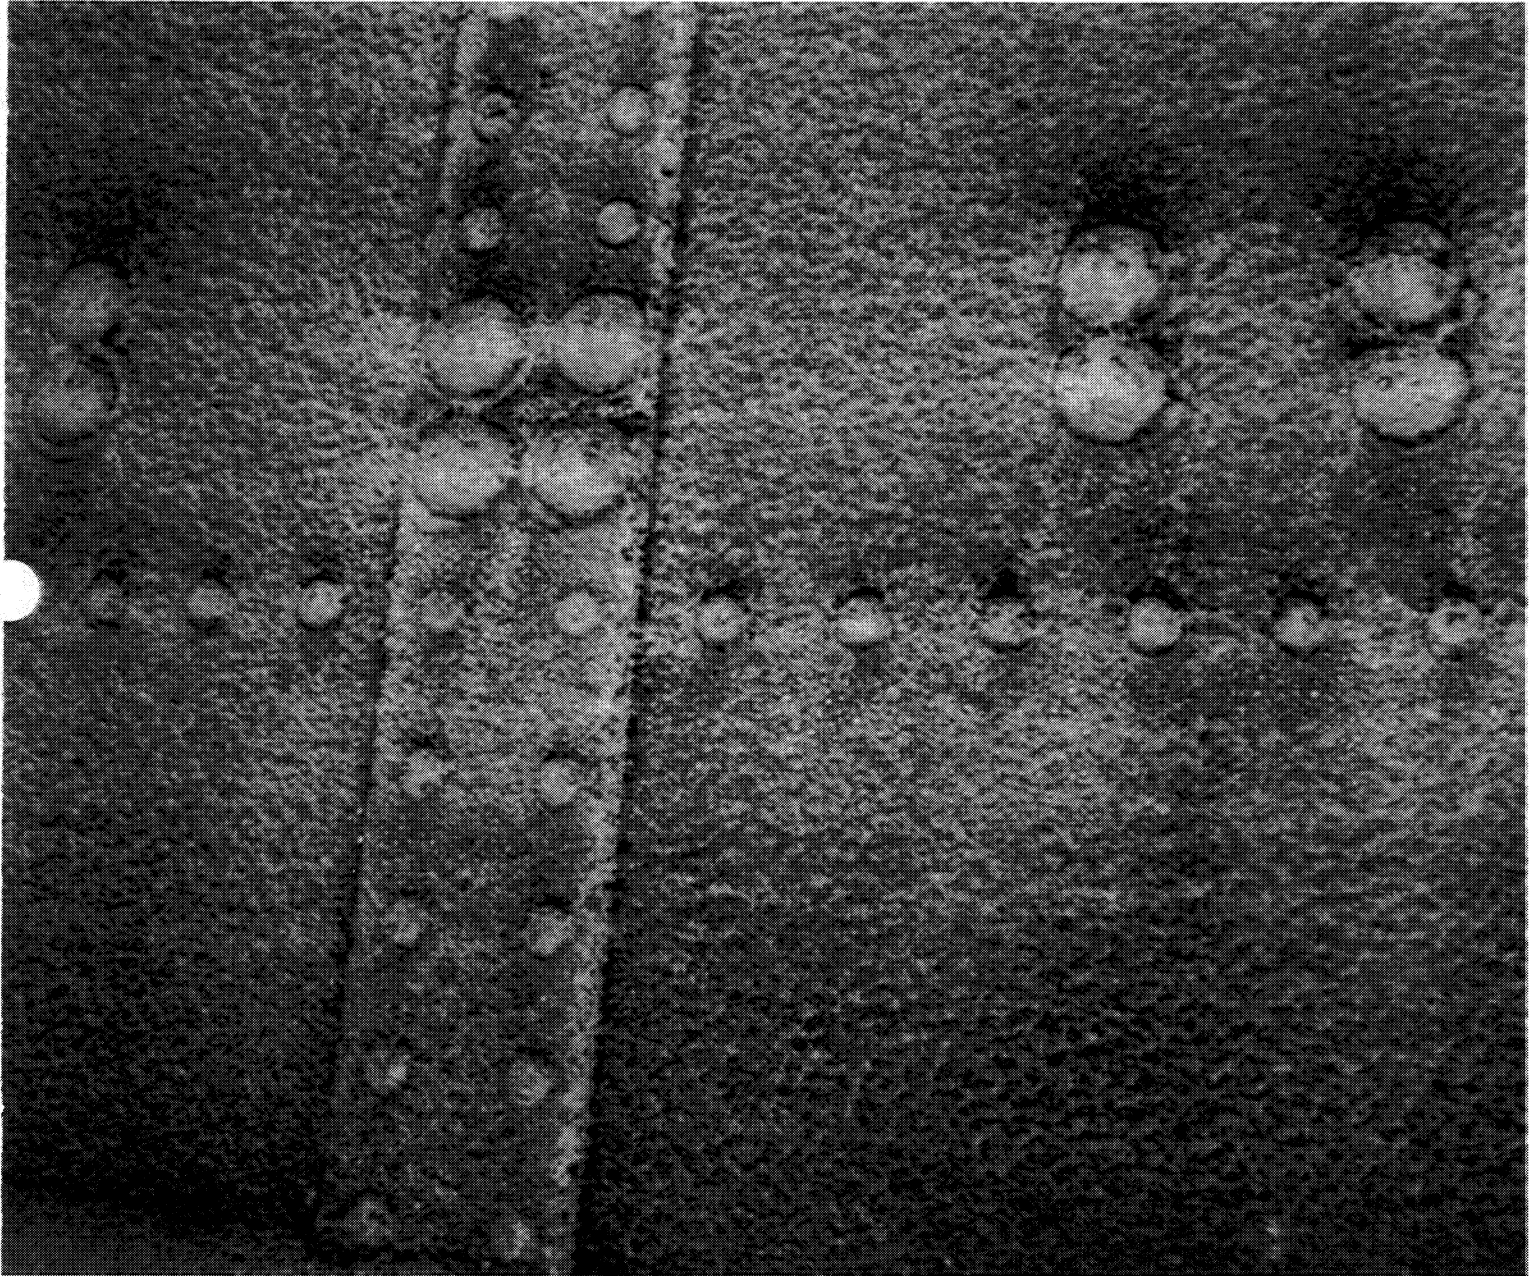
Photo 15: Elimination of Sealant/Cap Closeout

Close-up view of fastener heads covered by TPS.
Note ten PR-1422 sealant/cap closeouts for comparison.

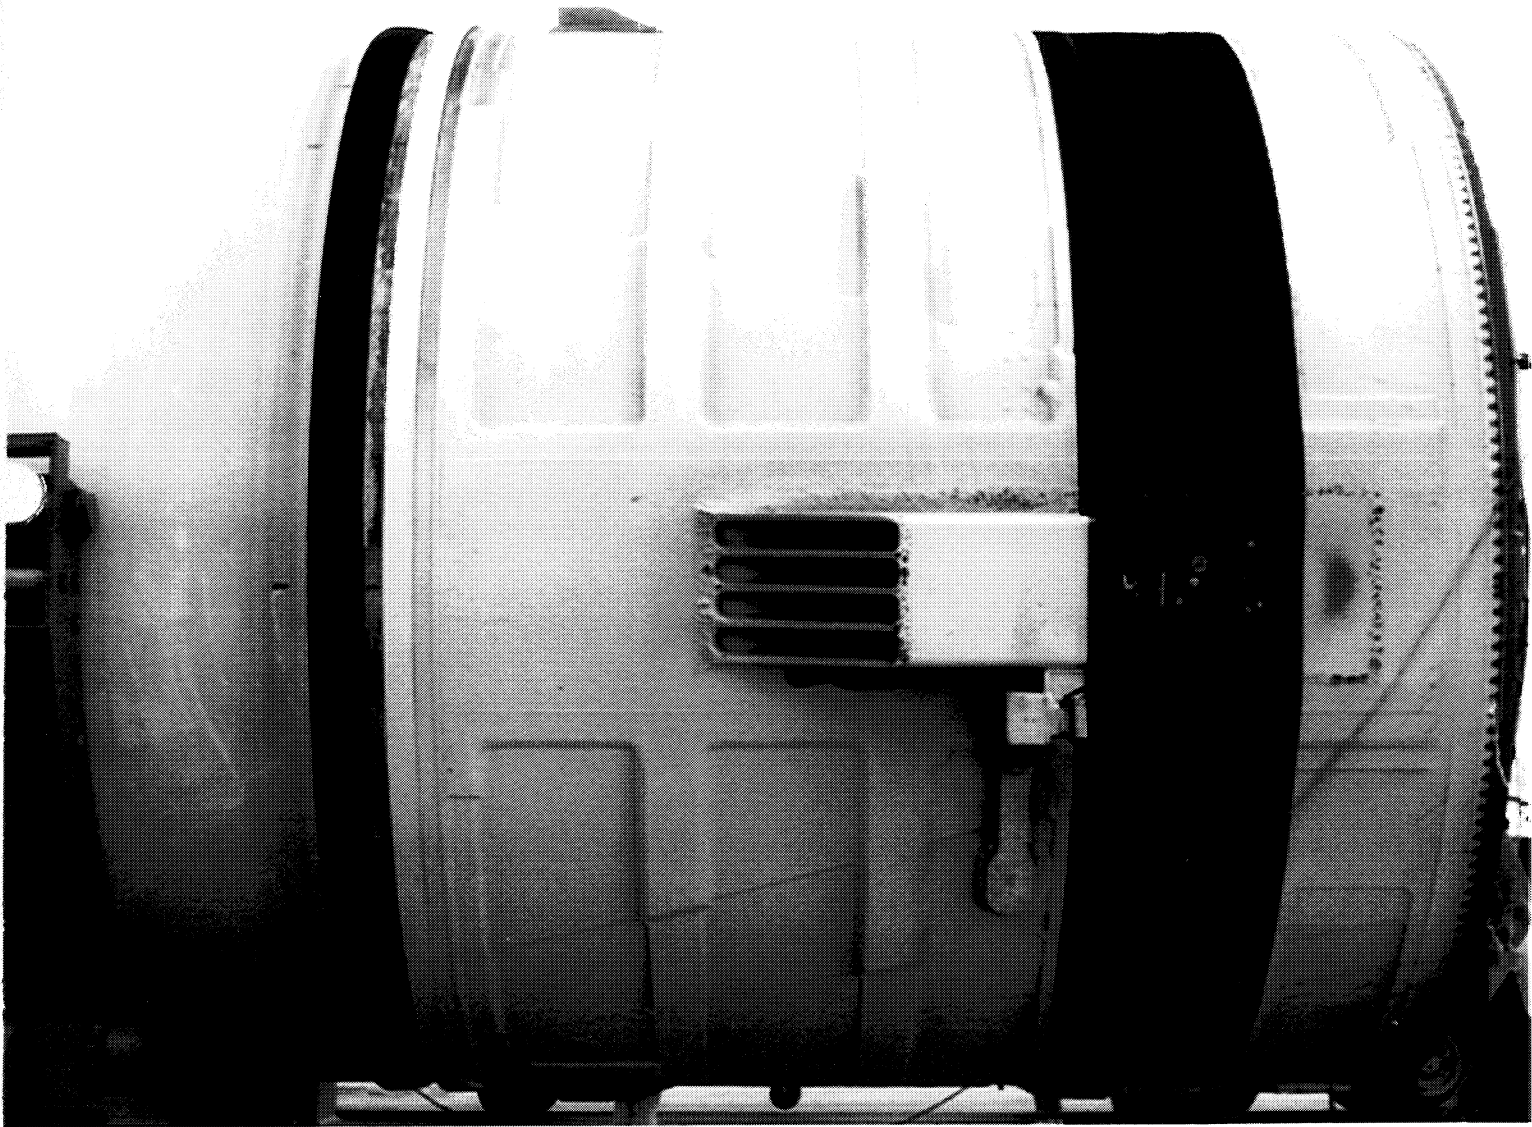
Photo 16: Forward Skirt Post Flight Condition

The forward skirts exhibited no debonds or missing TPS. RSS antennae covers/phenolic base plates were intact. Hypalon paint was blistered/missing over the areas where BTA closeouts had been applied. All frustum severance ring pins and retainer clips were intact.

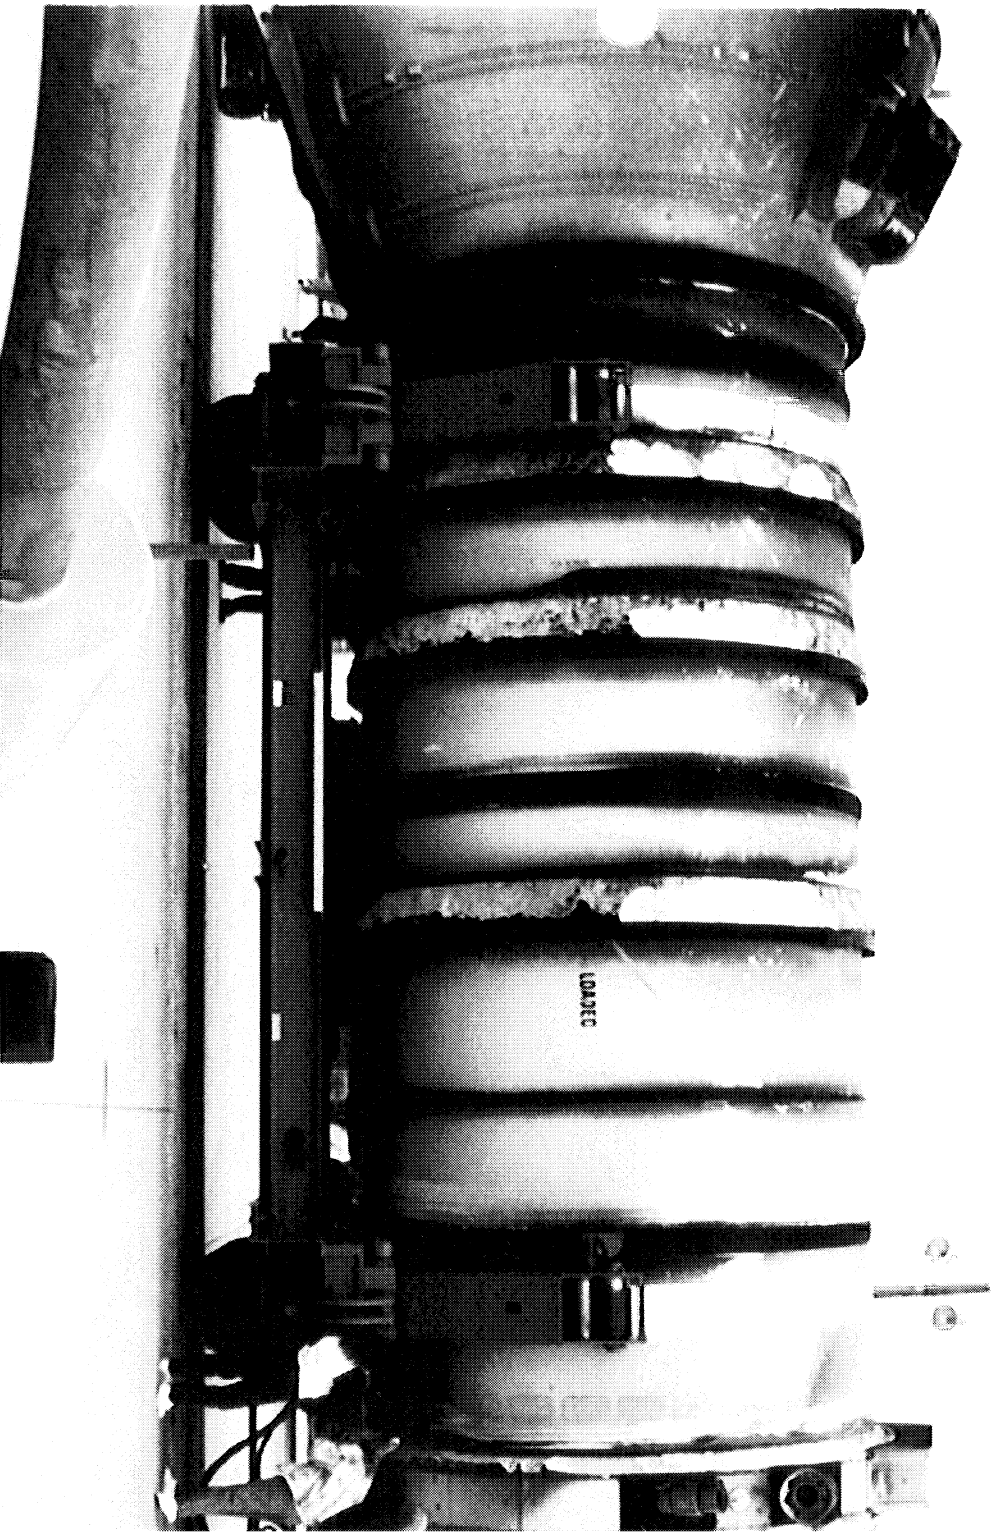
Photo 17: Aft Booster/Aft Skirt Post Flight Condition

Separation of the aft ET/SRB struts appeared normal. The stiffener rings, ETA rings, and IEA's appeared undamaged by water impact. TPS on the external surface of both aft skirts was intact and in good condition.

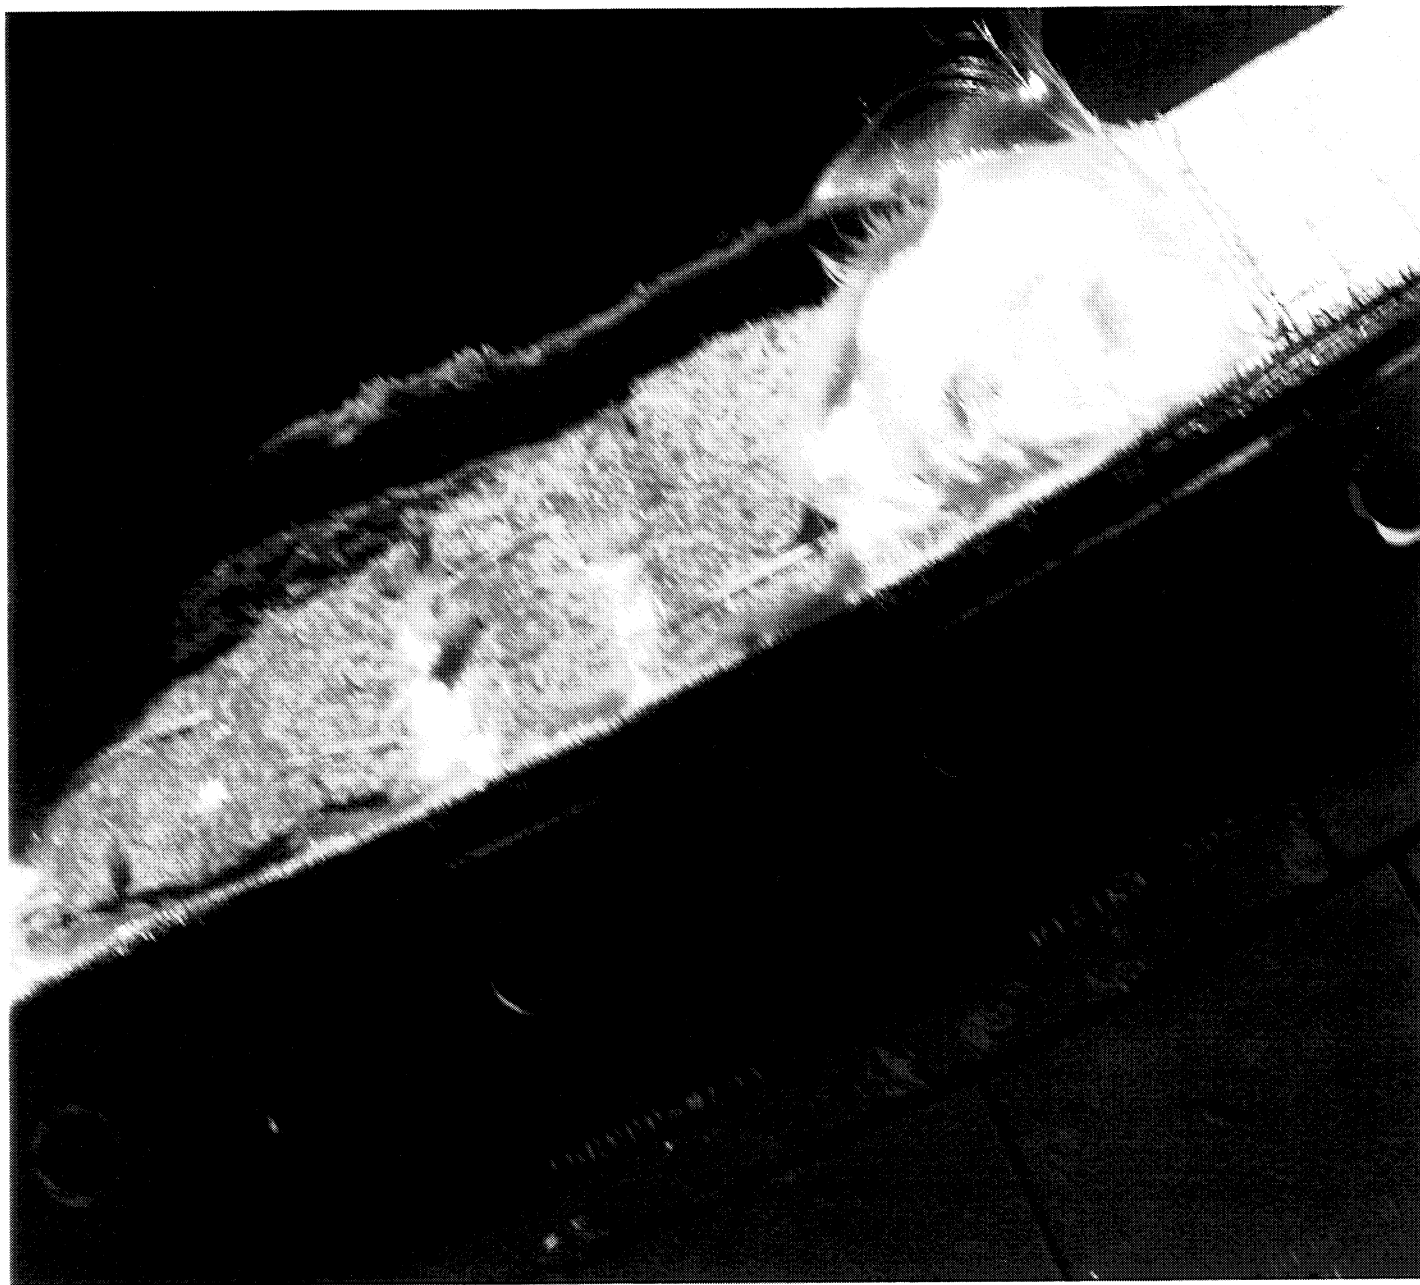
Photo 20: SSME #1 DMHS Blanket Damage

The blanket panels on SSME #1 at the 4-6:00 o'clock position were missing. The underlying batting material was torn and frayed. Loss of this material in flight was detected in the launch tracking films at T+39 seconds MET.

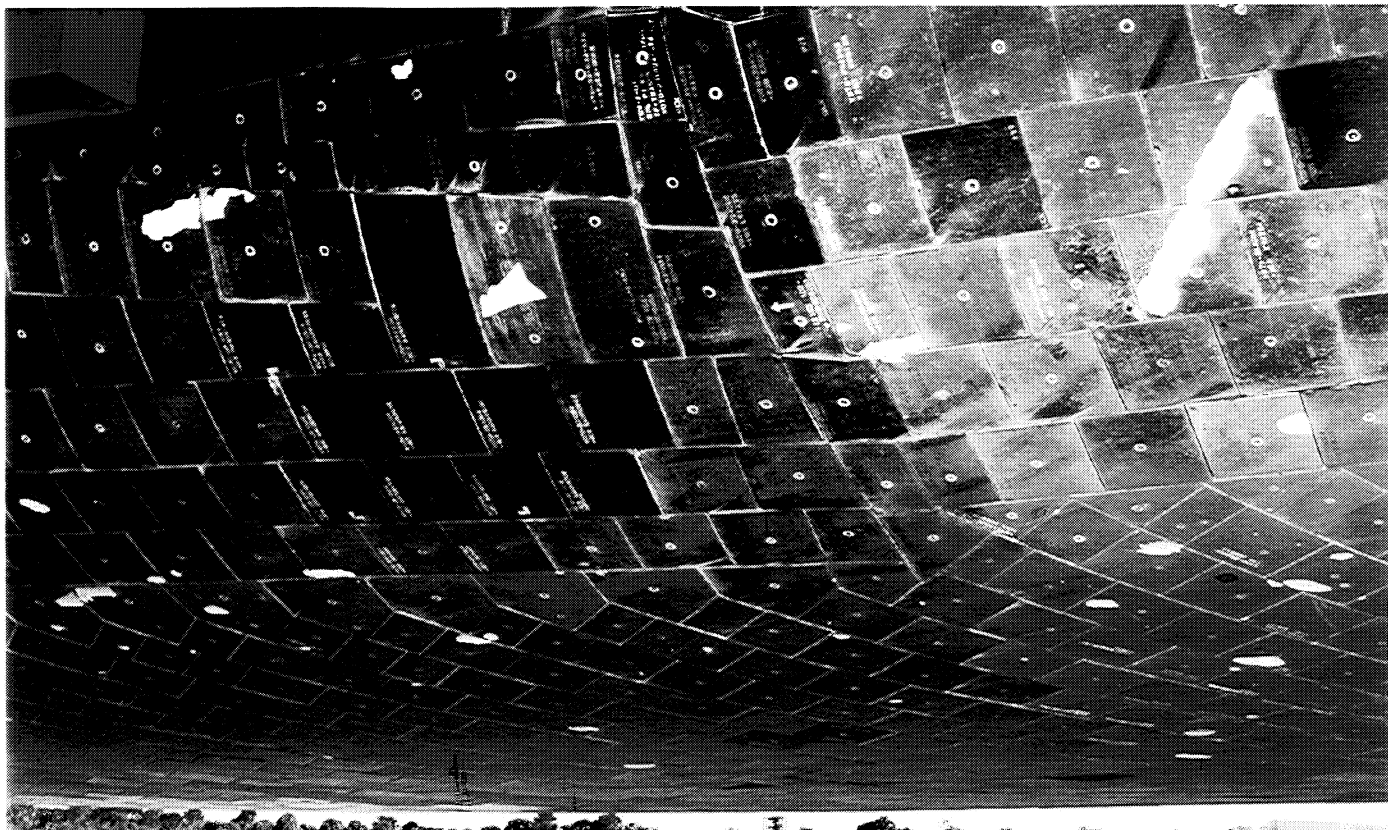
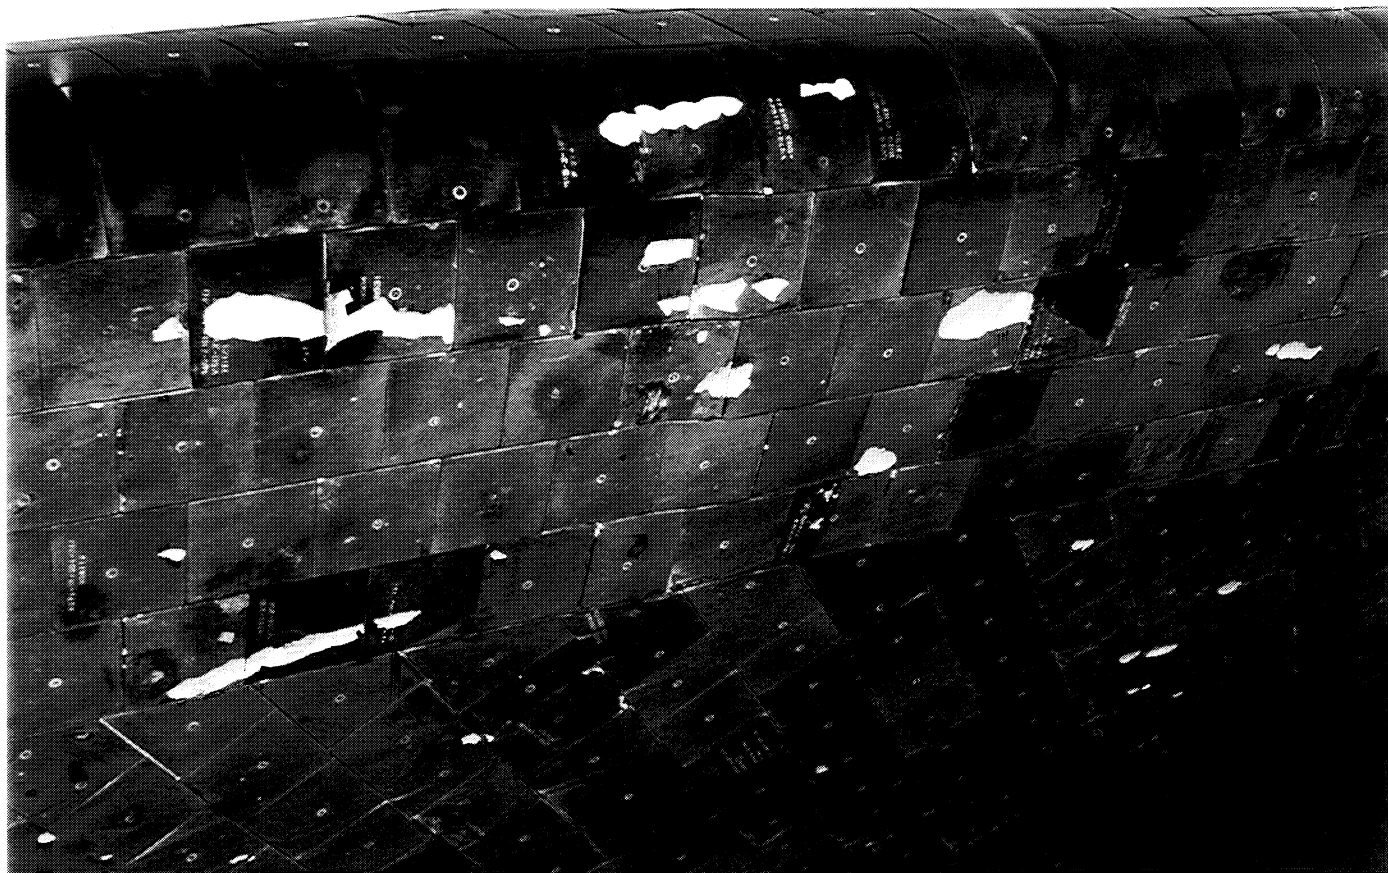
Photo 21: Lower Surface Tile Damage

The Orbiter lower surface sustained at least 244 significant hits, of which 109 had a major dimension of 1-inch or larger. Virtually all of this unusual damage was concentrated in the area between the nose landing gear and the main landing gear more or less symmetrically divided between left (top photo) and right (bottom photo) outboard sides. The largest lower surface tile damage site was located on the left glove. The site measured 15-inches long by 2-inches wide by 0.25-inches deep.

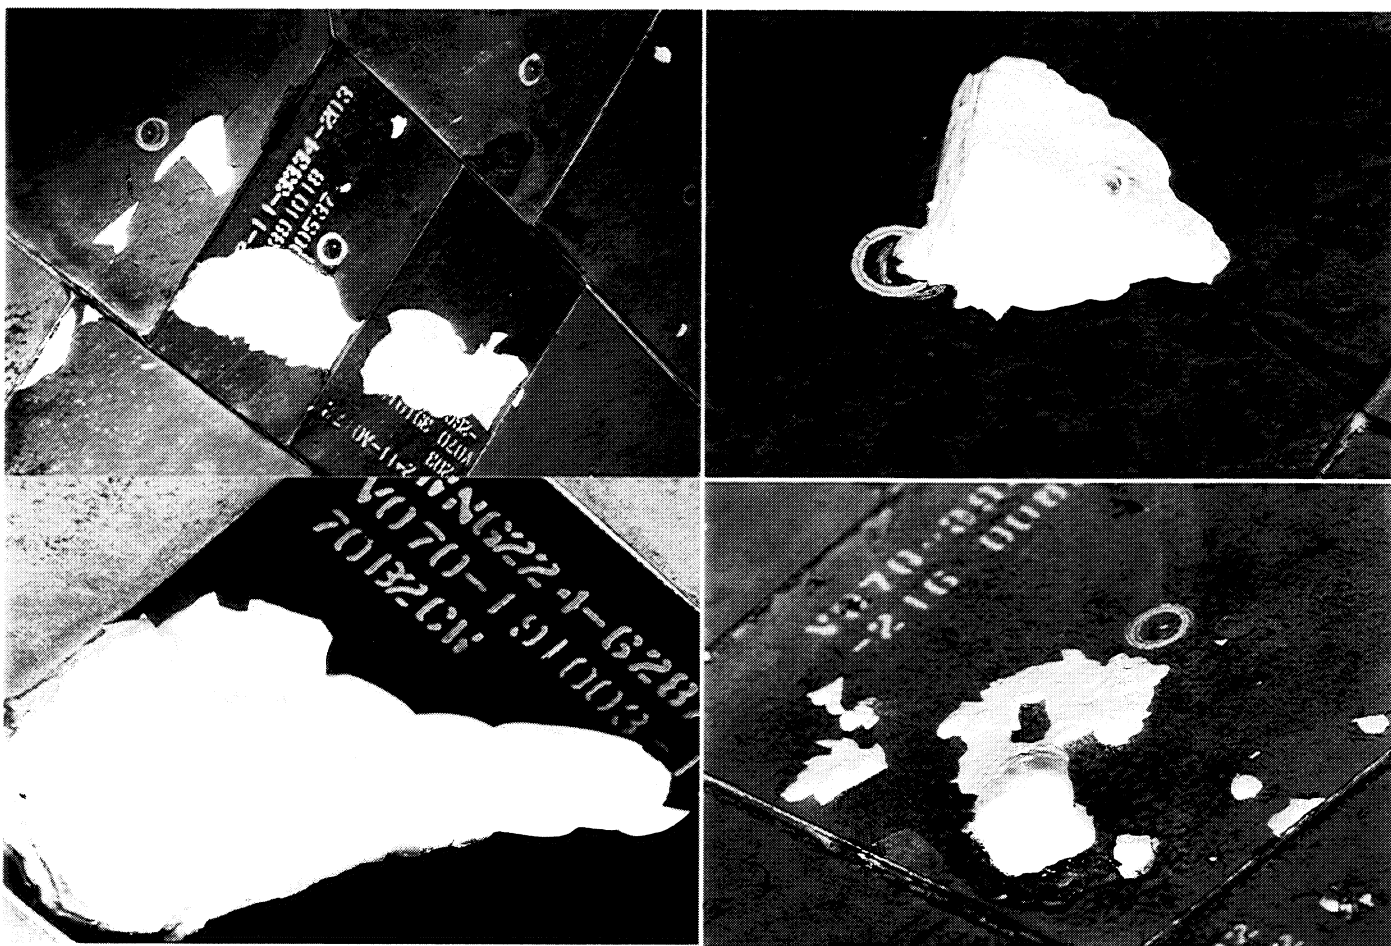
Photo 22: Lower Surface Tile Damage

The deepest lower surface tile damage site was located just forward of the left main landing gear well. It measured 4-inches long by 2-inches wide by 1.5-inches deep. Tile material in the damage sites showed signs of glazing and heat effects from re-entry. The damage sites with significant depth appeared to be generally aligned in a fore to aft direction. Many of these sites were affected by re-entry aerodynamic erosion.

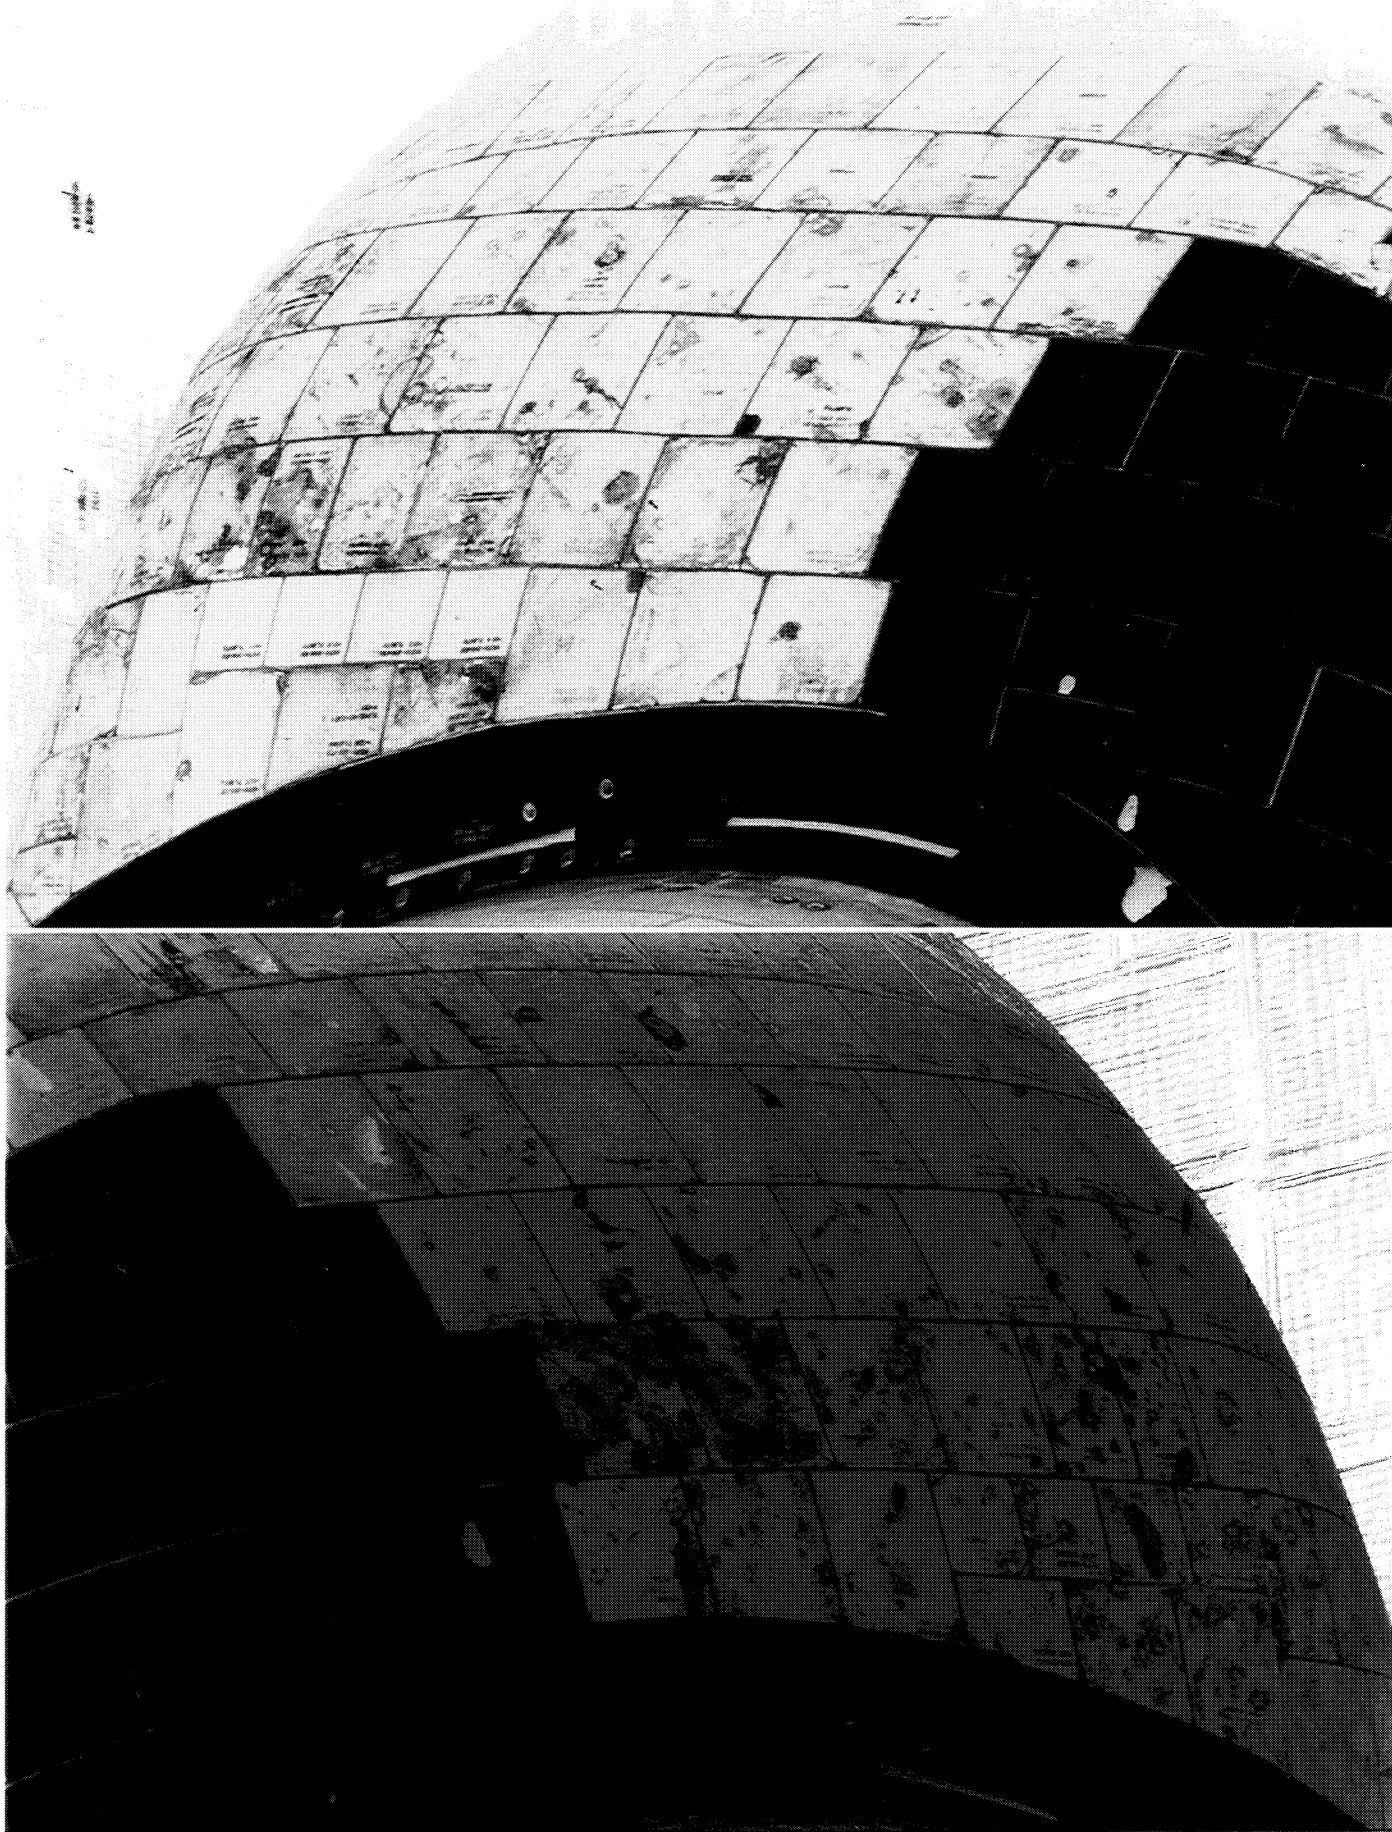
Photo 23: OMS Pod Tile Damage

Unusual tile damage occurred on the lower outboard leading edges of both OMS pods. There were 33 total hits, of which 14 were larger than 1-inch in size.

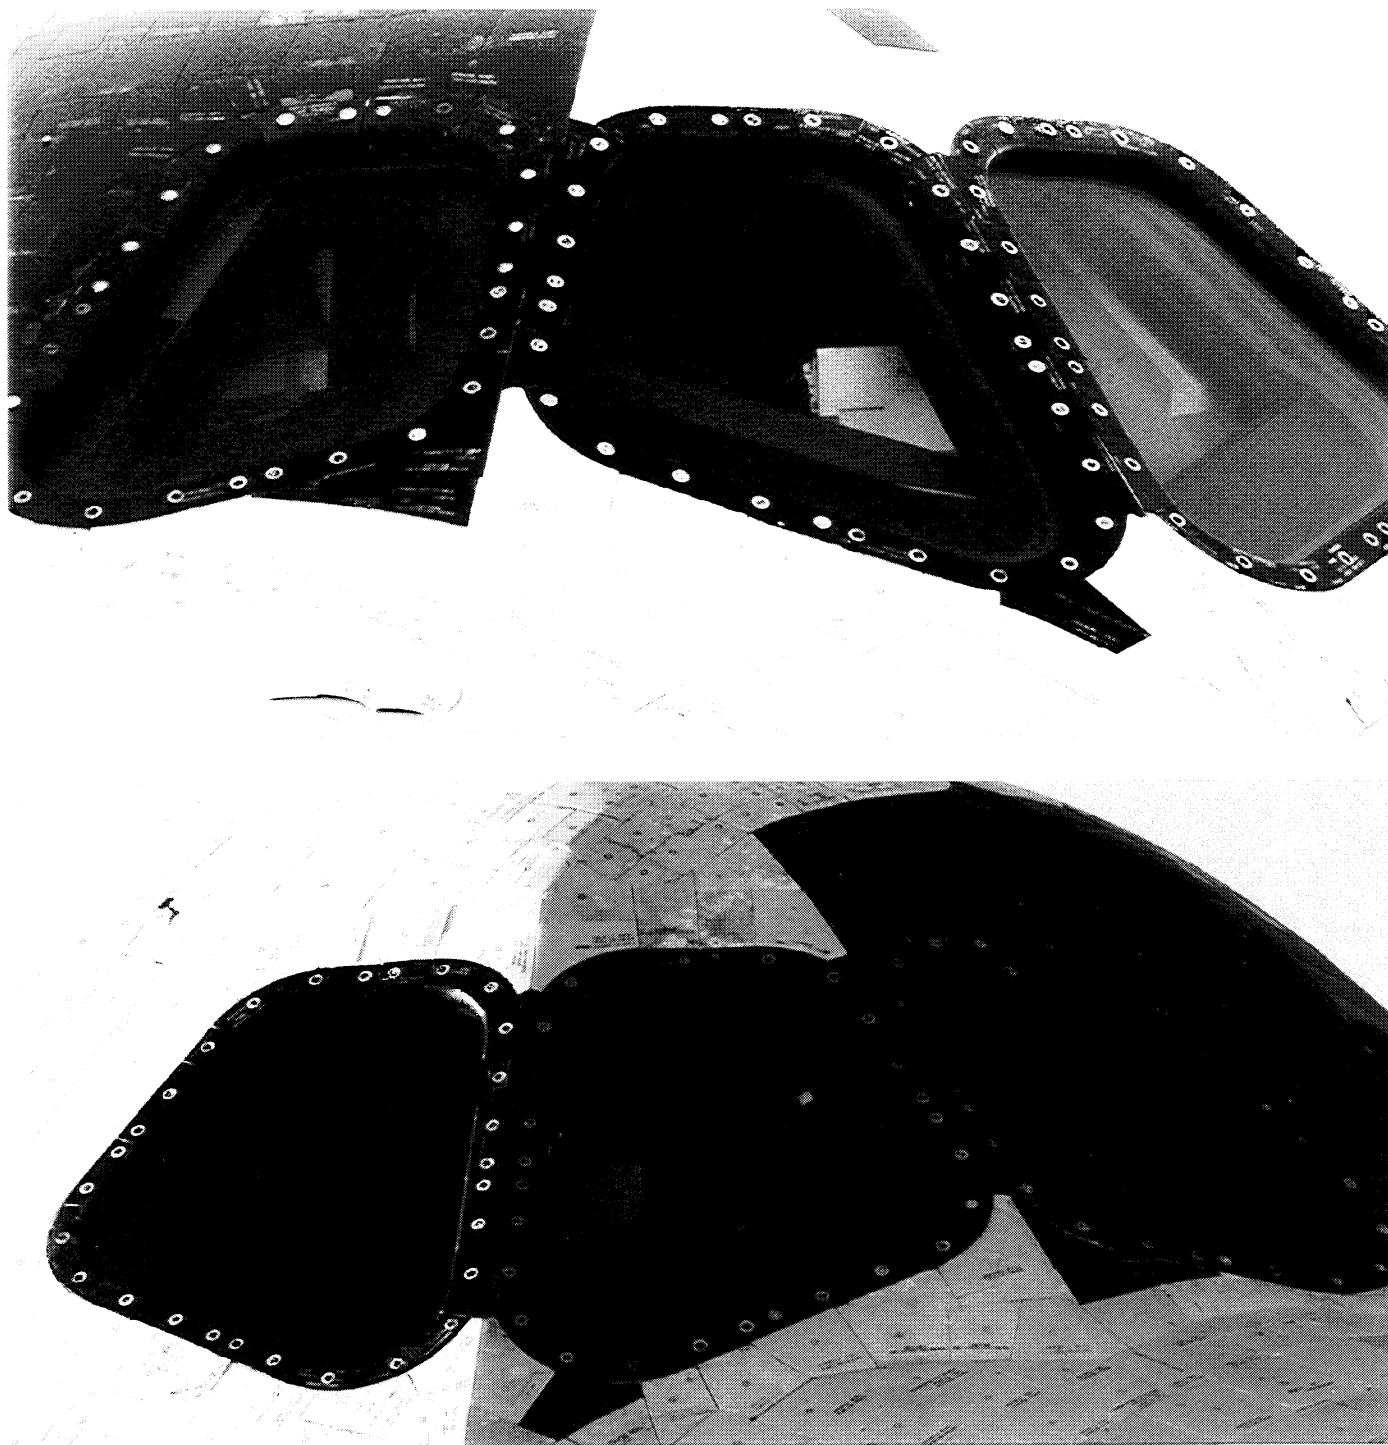
Photo 24: Windows and Perimeter Tiles

Hazing and streaking of forward-facing Orbiter windows was less than usual. Damage sites on the window perimeter tiles was noticeably less than usual in quantity and size.

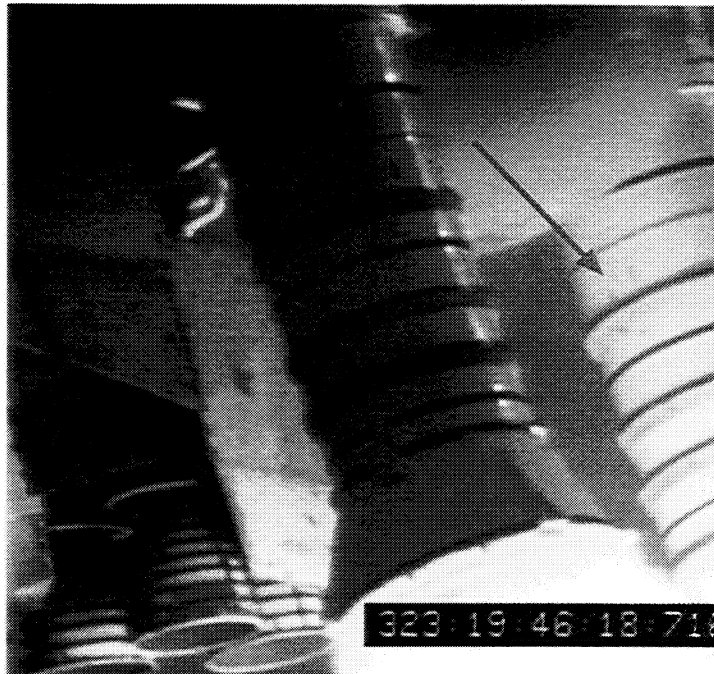
Figure 2.4 (A) Umbilical Purge Barrier Material

A piece of umbilical purge barrier material was seen to detach and travel toward the LSRB before falling aft (~19:46:18.7 UTC).

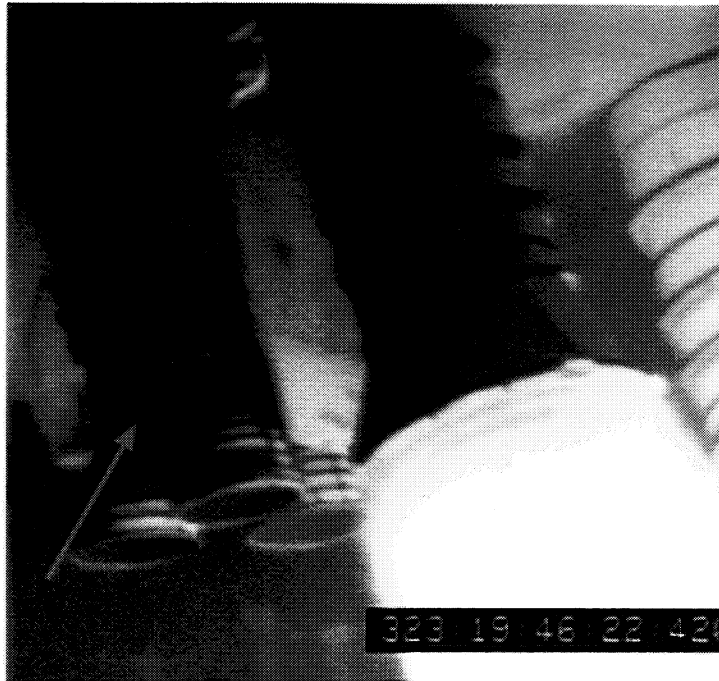
Figure 2.4 (C) Partially Detached Dome Mounted Heat Shield (DMHS) Closeout Blanket

A Dome Mounted Heat Shield (DMHS) closeout blanket was seen to partially detach at the 5 o'clock position of SSME #1 at ~19:46:20.7 UTC.

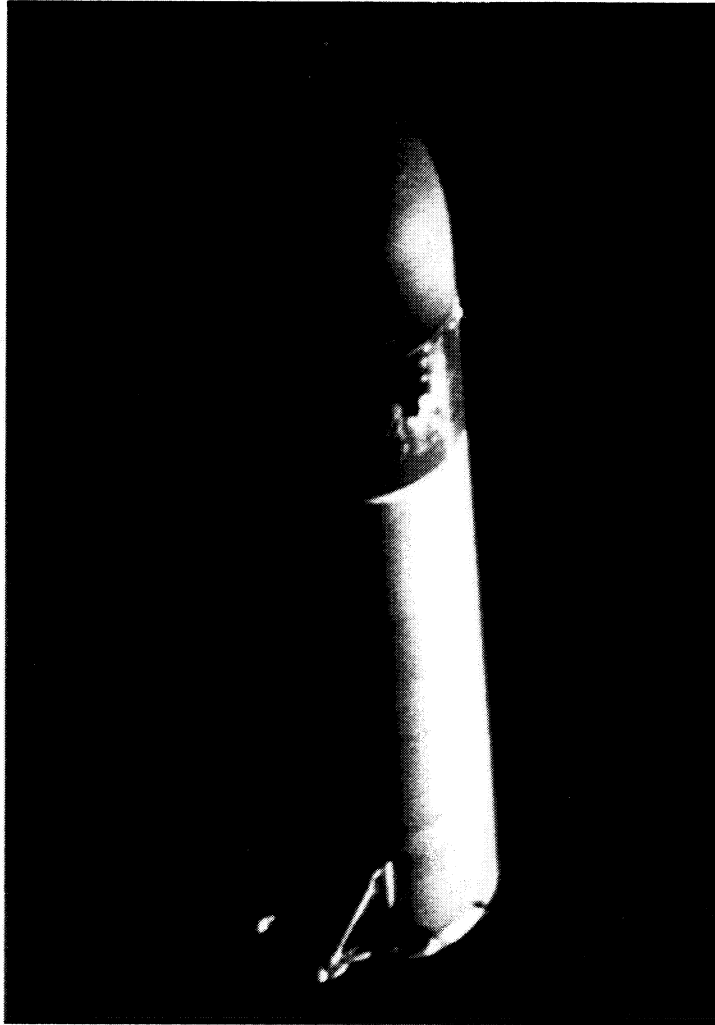
Figure 2.6.1.2 (A) Damage to the ET +Y Intertank Thrust Panel

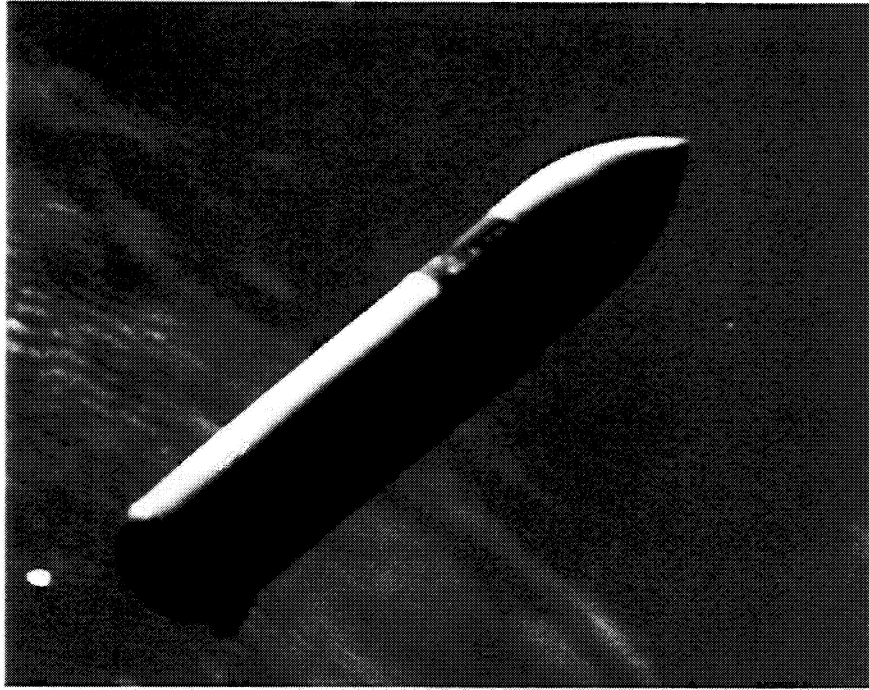
Figure 2.6.1.2 (B) Damage to the ET -Y Intertank Thrust Panel

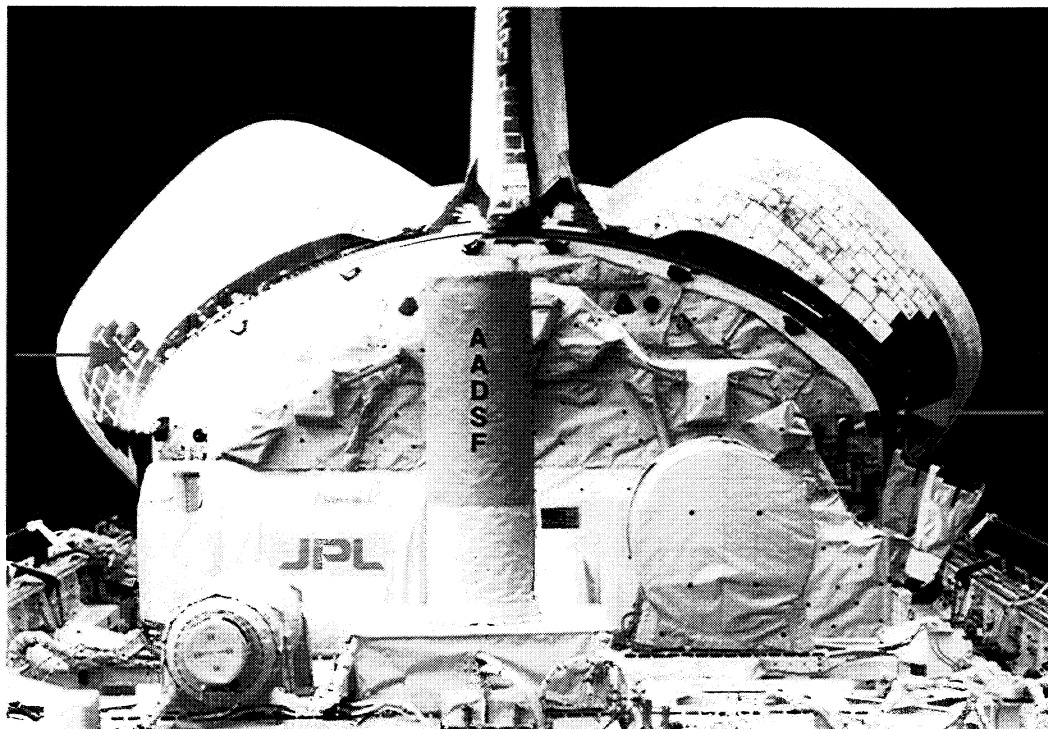
Figure 2.6.2 On-Orbit View of OMS Pod Damage
